PIC12F683 Rev. A Silicon/Data Sheet Errata

The PIC12F683 parts you have received conform functionally to the Device Data Sheet (DS41211D), except for the anomalies described below.

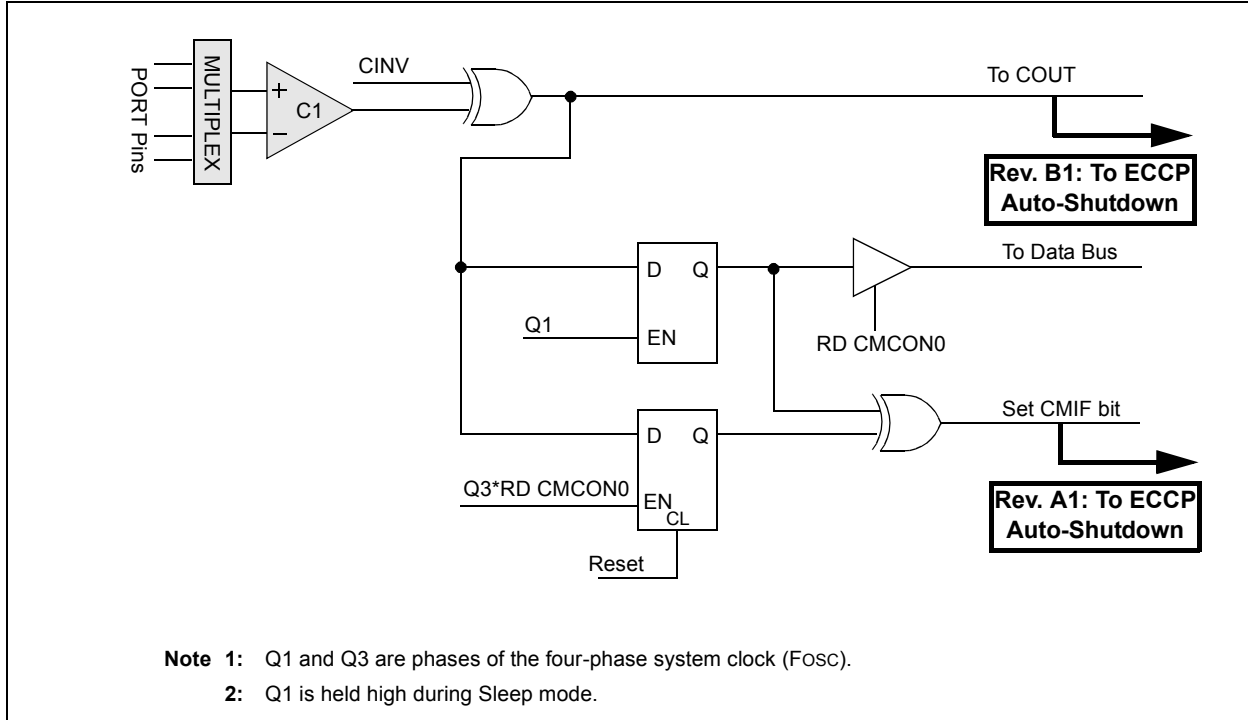
FIGURE 8-2: COMPARATOR C1 OUTPUT BLOCK DIAGRAM

The PIC12F683 Rev. A1 silicon for the ECCP Auto-Shutdown is connected to the CMIF flag. See Figure 8-2 on the following page.

Rev. A1's auto-shutdown connection to CMIF causes the auto-shutdown to incorrectly operate synchronously. Additionally, reads of CMCON0 will incorrectly clear an auto-shutdown event.

- 1) Poll the COUT bit until it is low.
- 2) Read CMCON1 to precondition CMIF.
- 3) If CMCON0 is read while COUT is changing, repeat steps 1 and 2.

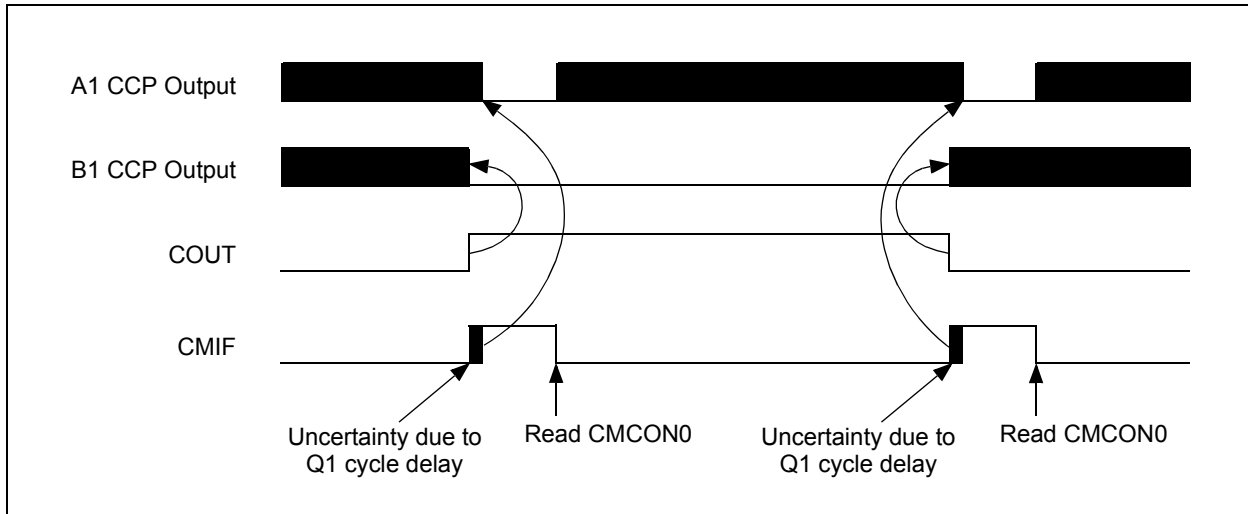
FIGURE 1: SILICON REVISION A1 VS. REVISION B1

The Silicon Rev. B1 device (now shipping) has moved the auto-shutdown connection from CxIF to CxOUT. This will eliminate the synchronous shutdown and simplify the use of the comparator for a shutdown event. Figure 1 shows the function of auto-shutdown before and after the device revision.
